SURVEY REPORT FOR ASBESTOS AND LEAD-BASED PAINT

**DELIVERY ORDER No. 0024
INTERIOR/EXTERIOR REPAIRS, BLDG. M116 (CHAPEL)
MARINE CORPS BASE – CAMP JOHNSON
JACKSONVILLE, NORTH CAROLINA**

ISSUE DATE: MAY 15, 2019

ACES PROJECT: 2019-03-017

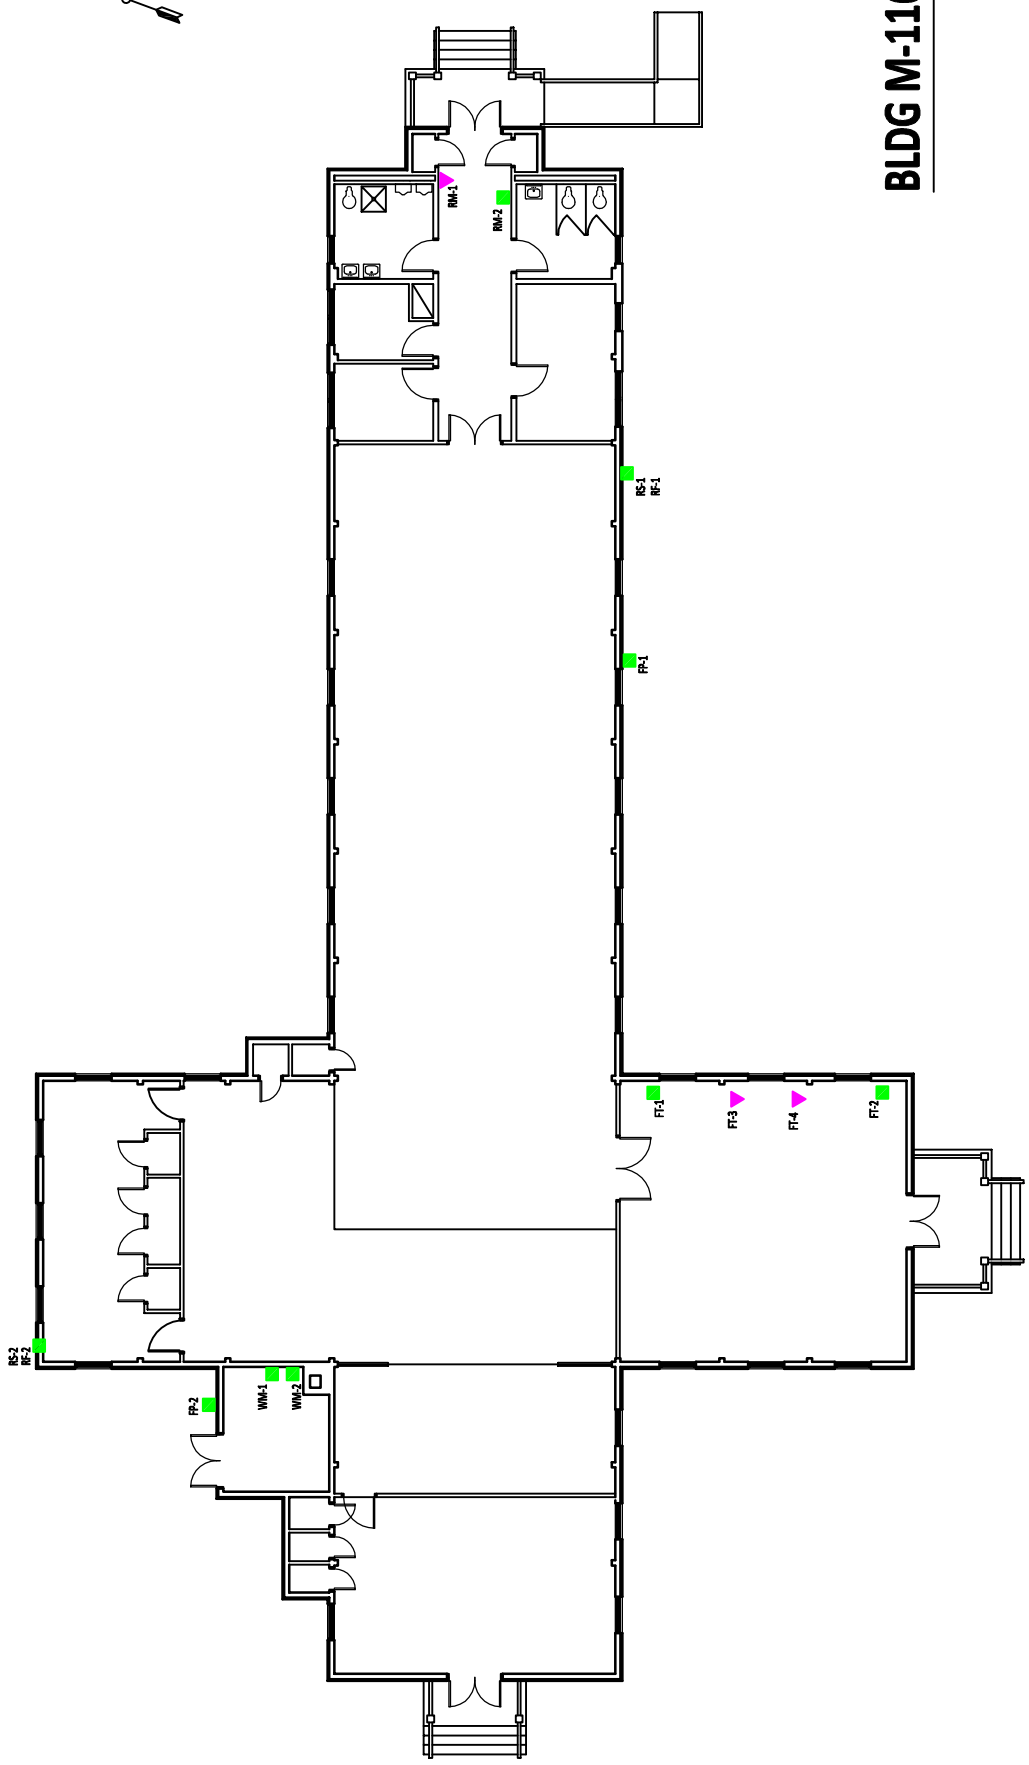
SAMPLE LOCATION PLAN

Asbestos was detected in the three (3) of the twenty-four (24) samples analyzed by EMSL. In addition, an asbestos report prepared by others indicated that non-friable ACM is present in the building. Materials identified that are known or presumed to contain asbestos are summarized in Table 1.

TABLE 1 – SUMMARY OF KNOWN or PRESUMED ACM		
ACM/PACM DESCRIPTION	REPORTED LOCATION	APPROX. QUANTITY
Residual Mastic	RM-1	160 sq. ft.
Bottom Mastic	FT-3	150 sq. ft.
Bottom Mastic	FT-4	---
Black Roofing Sealant	Roofing, Northwest Chimney Stack Flashing	12 sq. ft.

Asbestos containing materials (ACM) and Presumed Asbestos Containing Materials (PACM) were identified in the building. In their current condition, the materials are considered Category I Non-friable ACM or PACM. For the purposes of repair/renovation, the identified ACM and PACM should be considered Regulated Asbestos Containing Materials (RACM). These materials and any other suspect ACM where present should be removed prior to the renovation of the facilities by accredited personnel in accordance with applicable local, state, and federal

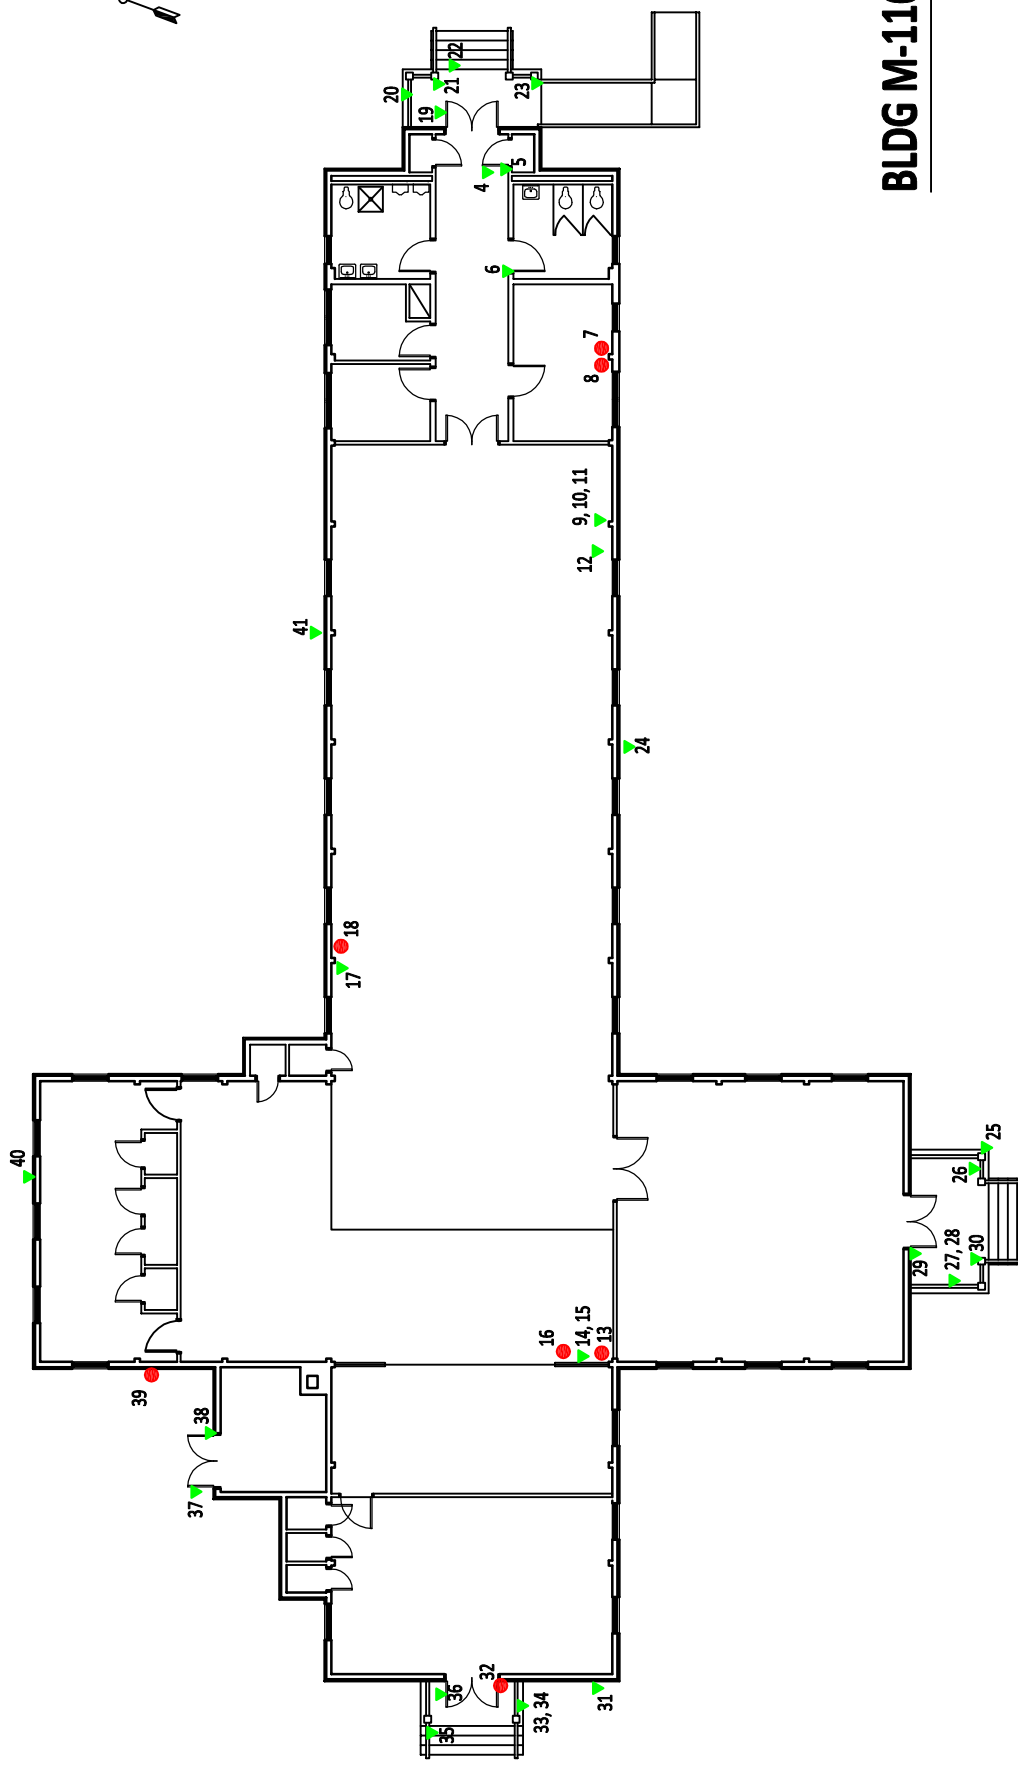
PROJ. NUM.: 2019 - 03 - 017
 DATE: May 13, 2019
SAMPLE LOCATION PLAN

The results of the testing (Appendix 3) revealed that lead-based paint was present at seven (7) locations associated with Building M-116 as shown in Table 2.

TABLE 2 – SUMMARY OF LEAD-BASED PAINT FINDINGS						
FACILITY ID.	XRF TEST NO.	INT./EXT.	FEATURE	SUBSTRATE	COLOR	XRF RDG. ¹
M-116	7	Interior	Column	Wood	White	1.45
M-116	8	Interior	Brace	Metal	White	> 5.0
M-116	13	Interior	Truss Upper Chord	Wood	Tan	1.44
M-116	16	Interior	Truss Lower Chord	Wood	White	1.41
M-116	18	Interior	Truss Member (Horiz.)	Wood	White	1.50
M-116	32	Exterior	Door Frame	Wood	White	> 5.0
M-116	39	Exterior	Siding (original)	Wood	White	4.43

15	W	Truss lower chord	W	See Figure 2	1 st		0.55	mg/cm ²	N
16	W	Truss lower chord	W	See Figure 2	1 st		1.41	mg/cm ²	P
17	Cardboard	Ceiling	W	See Figure 2	1 st		0.00	mg/cm ²	N
18	W	Truss member (horizontal)	W	See Figure 2	1 st		1.50	mg/cm ²	P
19	M	Door frame	W	See Figure 2	1 st		0.00	mg/cm ²	N
20	W	Railing	Gr	See Figure 2	1 st		0.00	mg/cm ²	N
21	M	Column	W	See Figure 2	1 st		0.00	mg/cm ²	N
22	W	Step	Gr	See Figure 2	1 st		0.00	mg/cm ²	N
23	M	Column	W	See Figure 2	1 st		0.00	mg/cm ²	N

Lead-based paint (LBP), i.e. paint that contains lead equal to or exceeding one milligram per square centimeter (1.0 mg/cm²), was identified at seven (7) locations on the painted surfaces tested at the building as shown in Table 2. ACES recommends that the lead paint on the various surfaces not be disturbed as a part of the repair/renovation activities unless necessary as a result of the repair and/or renovation. If the painted surfaces must be disturbed, removal of the LBP should be performed in accordance with local, state, and federal regulations.

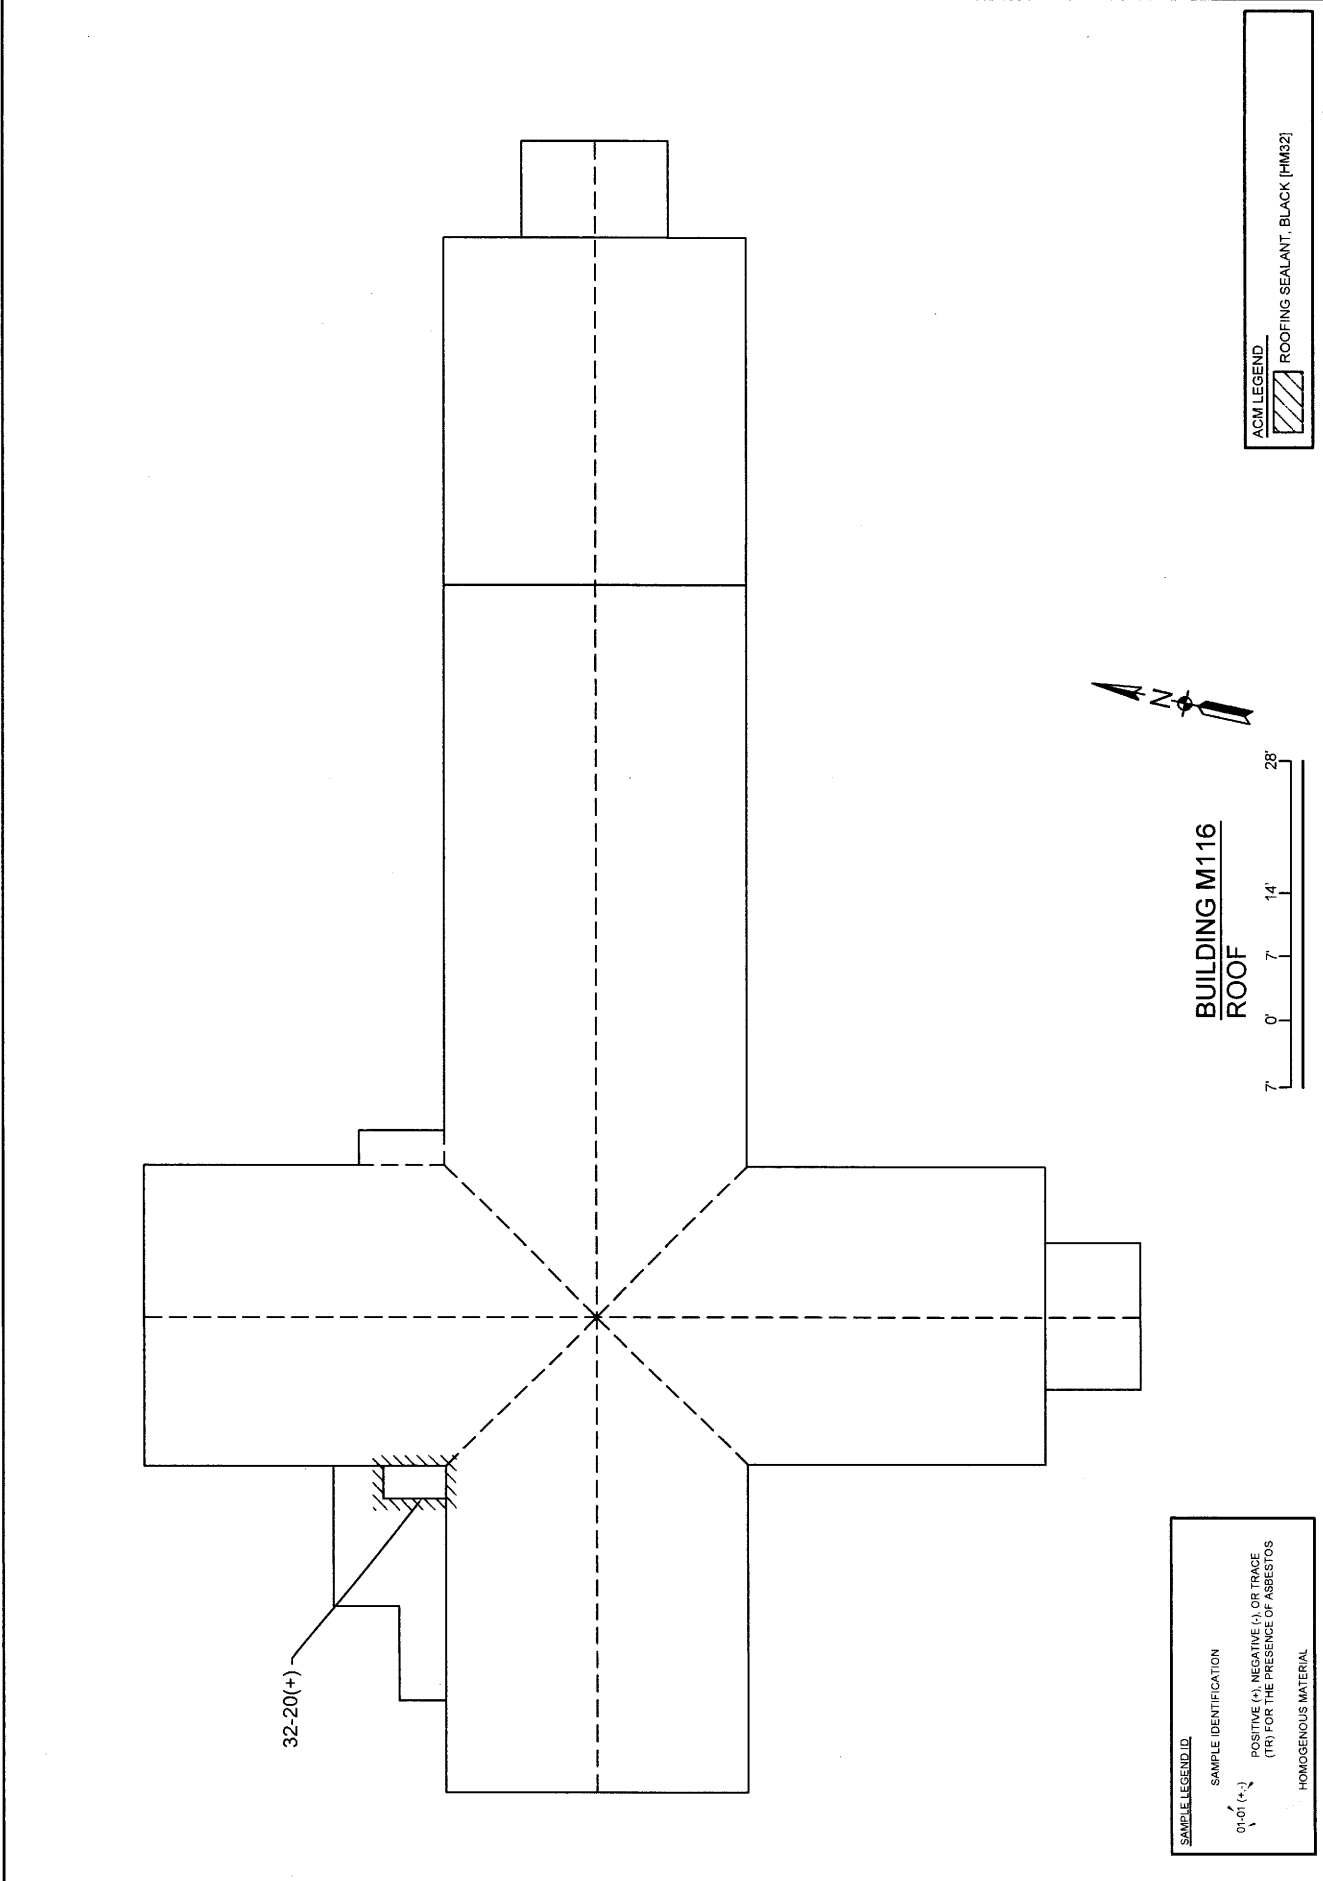
CY2016 ASBESTOS INSPECTION
M116-R
MCB CAMP LEJEUNE, NC

<i>DESCRIPTION</i>	<i>LOCATION</i>	<i>Date</i>	<i>Quantity</i>
ROOFING SEALANT, BLACK	ROOFING, NORTHWEST CHIMNEY STACK FLASHING	11/27/2007	12 SF
ROOFING SEALANT, BLACK	ROOFING, NORTHWEST CHIMNEY STACK FLASHING	8/22/2016	12 SF
ROOFING SEALANT, BLACK	ROOFING, NORTHWEST CHIMNEY STACK FLASHING	1/8/2010	12 SF
ROOFING SEALANT, BLACK	ROOFING, NORTHWEST CHIMNEY STACK FLASHING	4/30/2014	12 SF

ROOFING SEALANT, BLACK (HM32)
